Debris/Ice/TPS Assessment and Integrated Photographic Analysis of Shuttle mission STS-97

Technical Memorandum – 2001 – 208589

January 2001

November 30, 2000

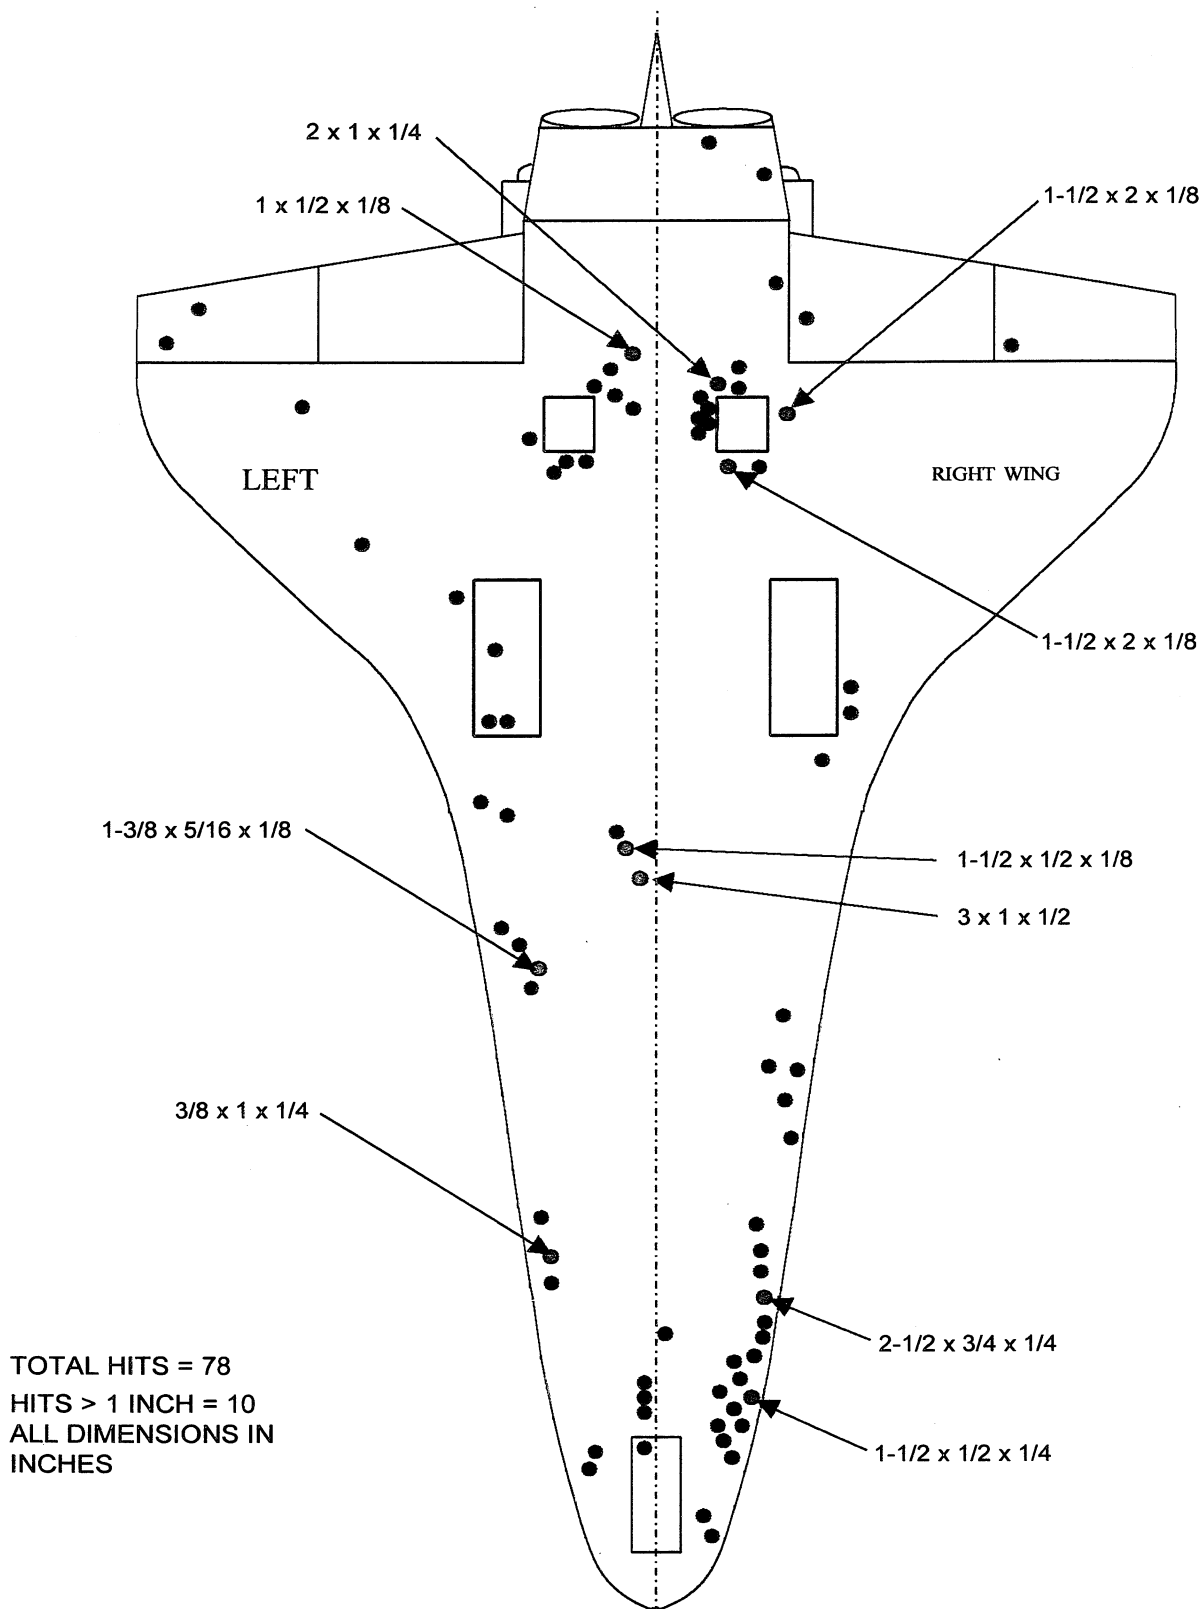
Figure 1: Orbiter Lower Surface Debris Damage Map

Post landing inspection of Orbiter tiles showed a total of 84 hits, of which 10 had a major dimension of 1-inch or larger. The Orbiter lower surface sustained 78 total hits, of which 10 had a major dimension of 1-inch or larger. Approximately 43 damage sites (with three larger than 1-inch in length) were located in the area from the nose gear to the main landing gear wheel wells. More damage occurred on the right-hand side of the vehicle than on the left-hand, with a typical pattern, some of these hits may be attributed to impacts from ice in the LO2 feedline bellows.

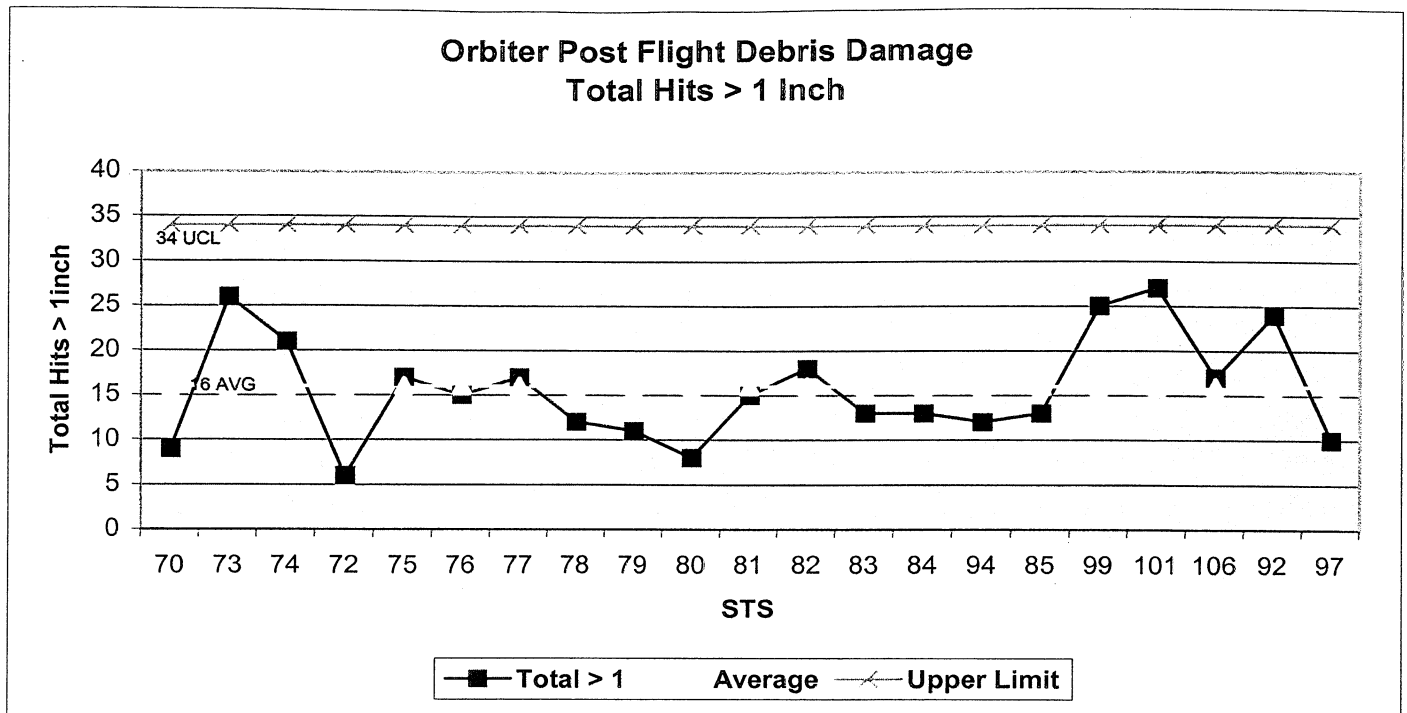
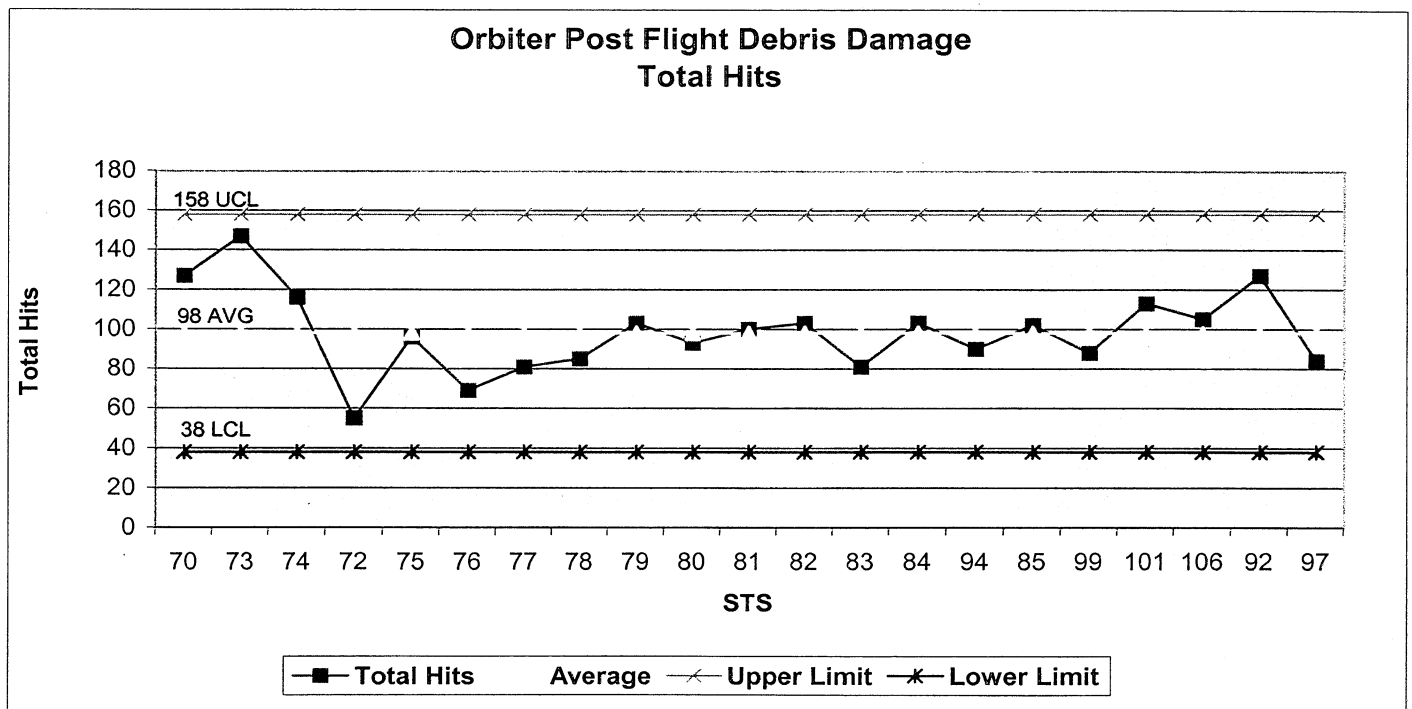
Figure 4: Control Limits for Lower Surface Hits

In summary, both the total number of Orbiter TPS debris hits and the number of hits 1-inch or larger were well within established family (reference Figures 3, 4 and 5).

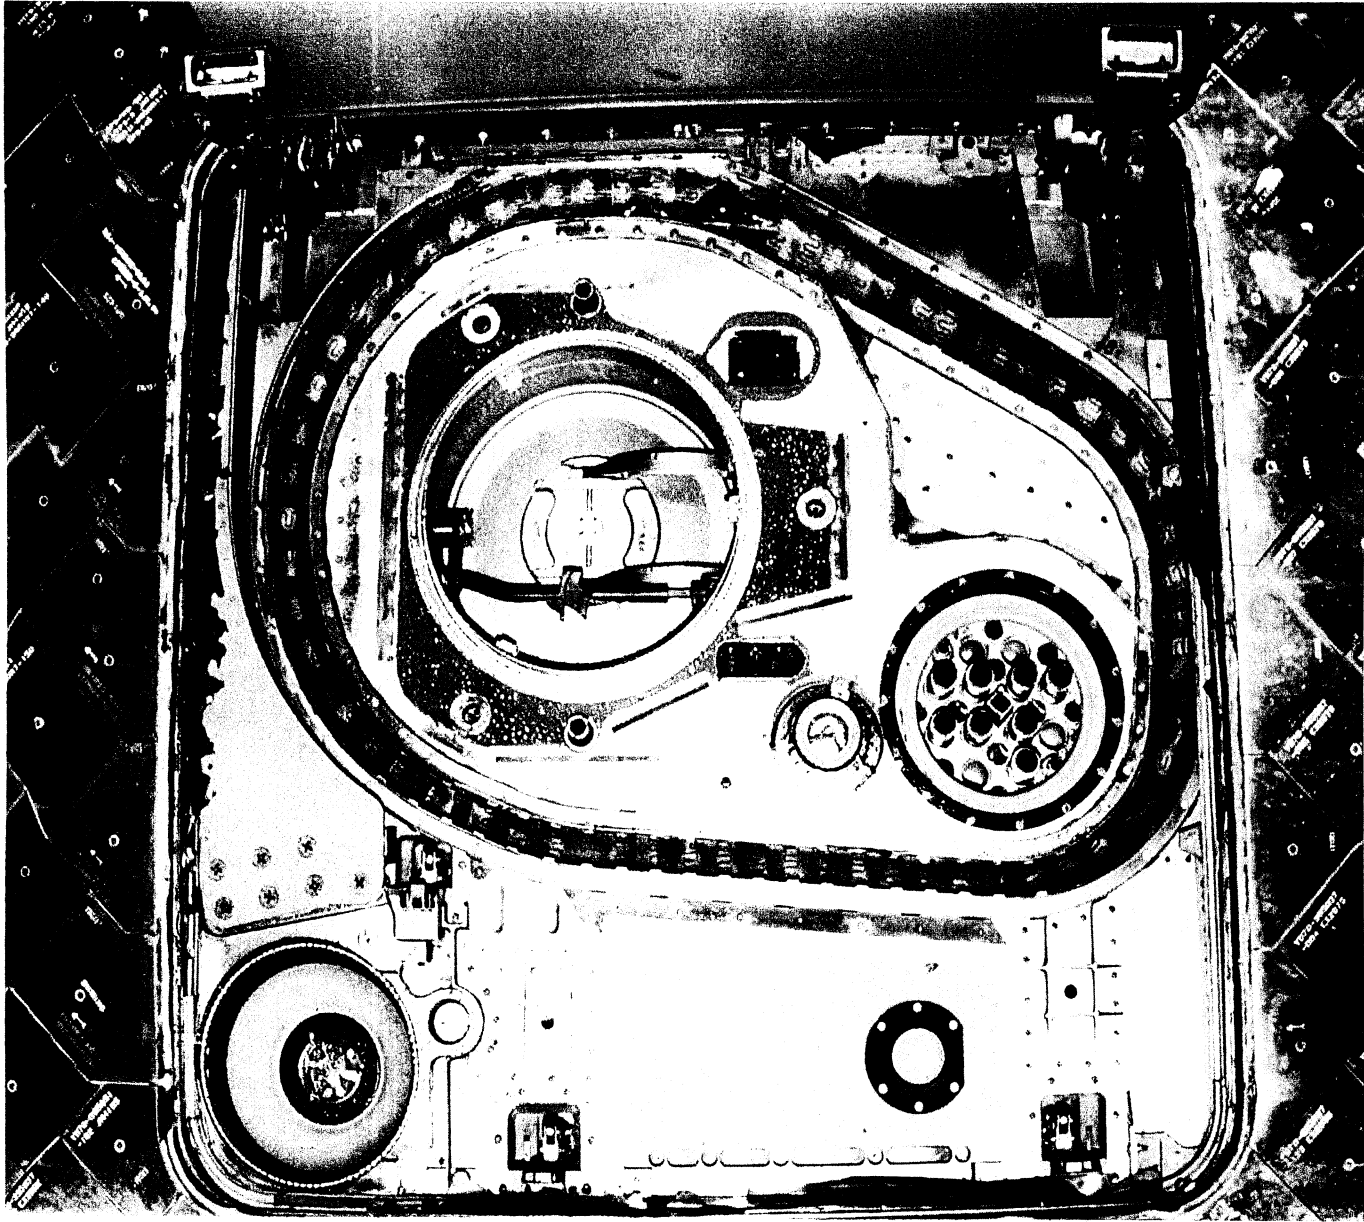
Photo 20: LO2 ET/ORB Umbilical

There were no TPS anomalies on the LO2 ET/ORB umbilical. Ice/frost accumulations were present on the aft and inboard sides. Ice/frost fingers on the separation bolt pyrotechnic canister purge vents were typical.

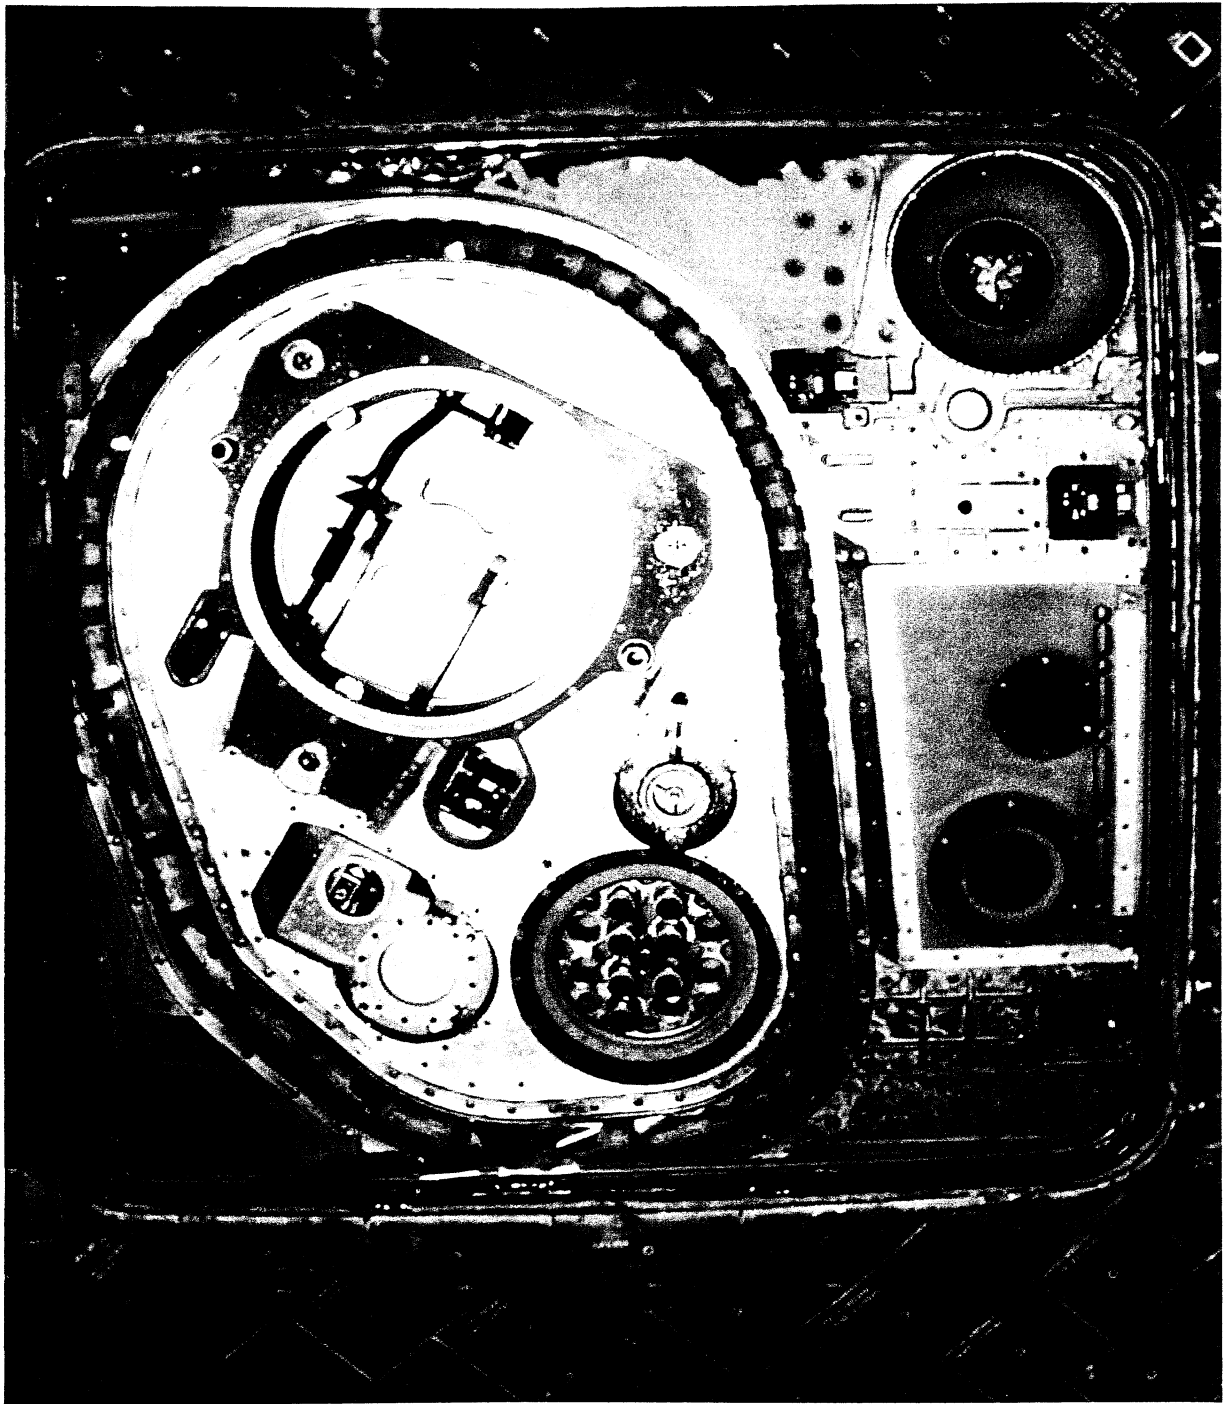
Photo 21: LH2 ET/ORB Umbilical

Ice and frost in the LH2 recirculation line bellows and on both burst disks was typical. Likewise, a typical amount of ice/frost had accumulated on the LH2 ET/ORB umbilical purge barrier outboard side, forward, and aft surfaces. Typical ice/frost fingers were present on the pyro canister and plate gap purge vents. No unusual vapors or cryogenic drips had appeared during tanking, stable replenish, and launch.

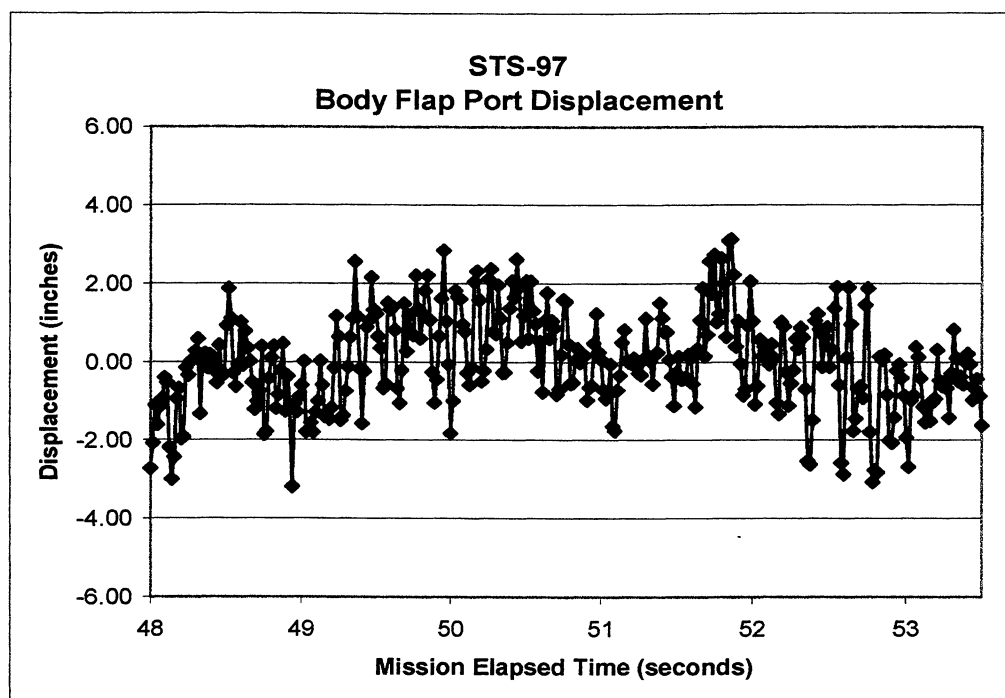
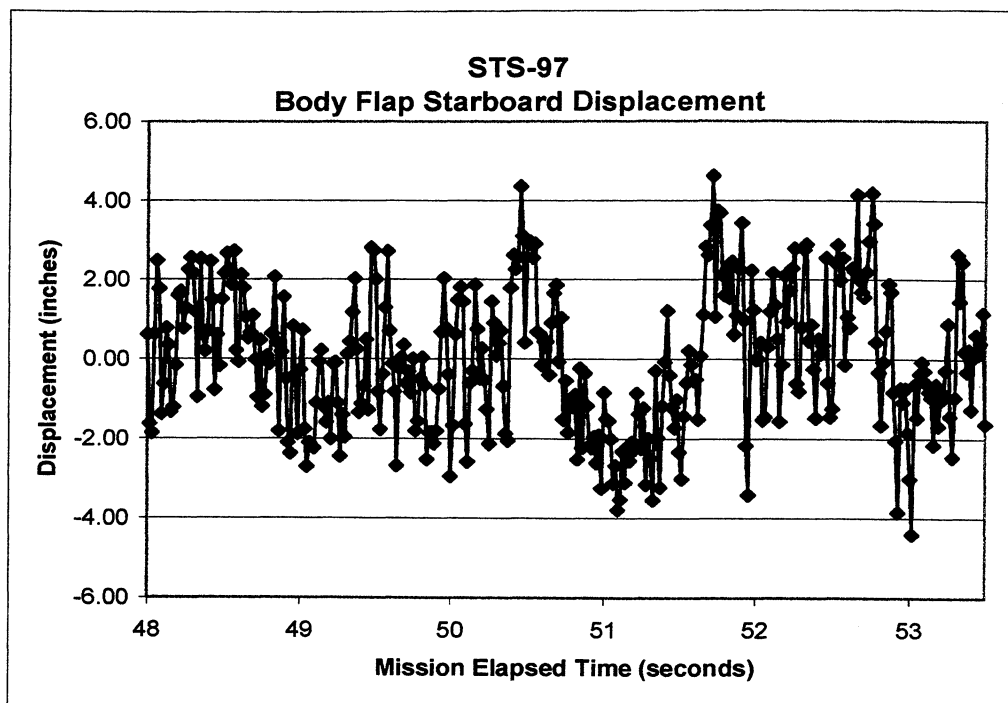
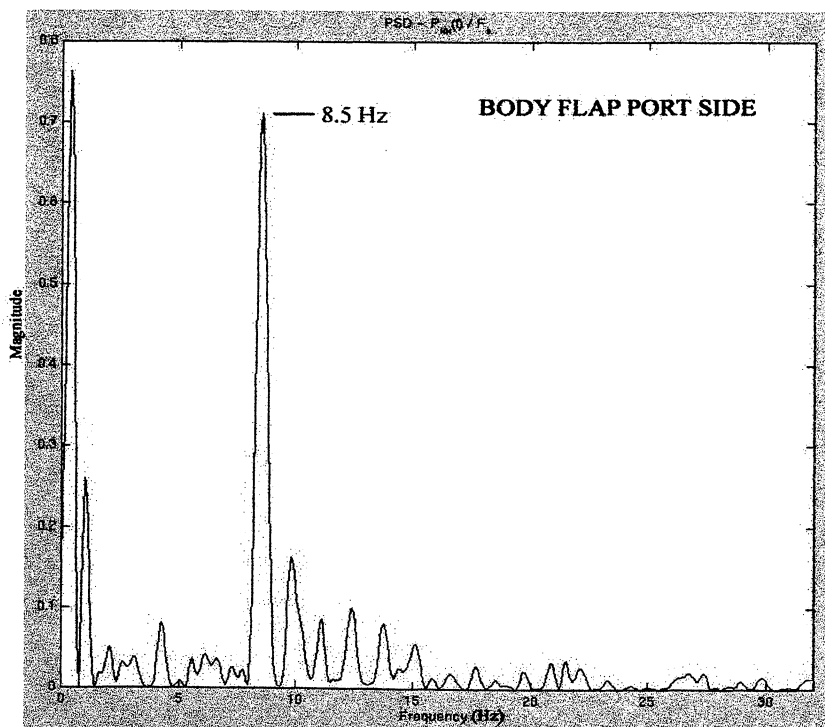
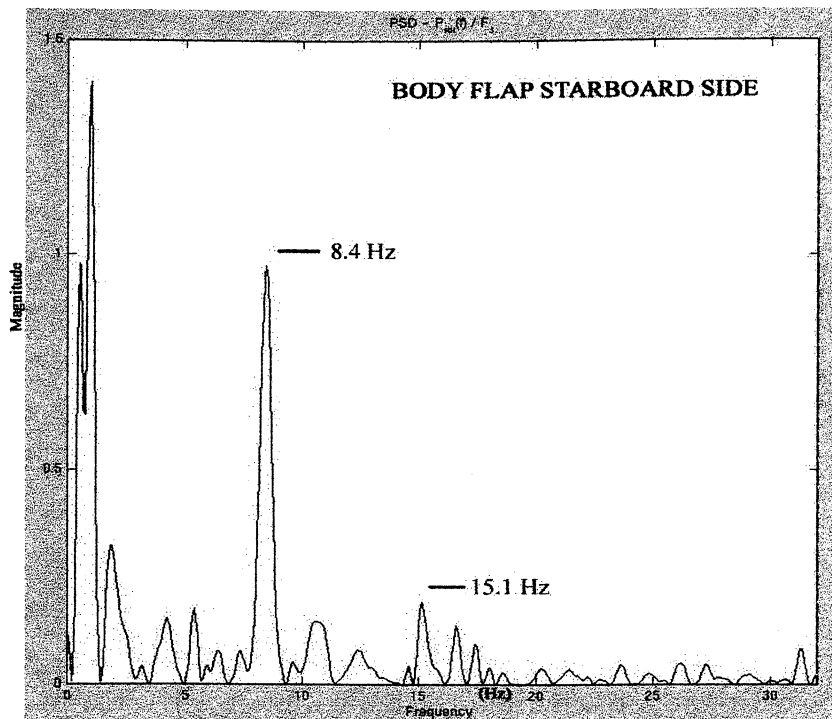
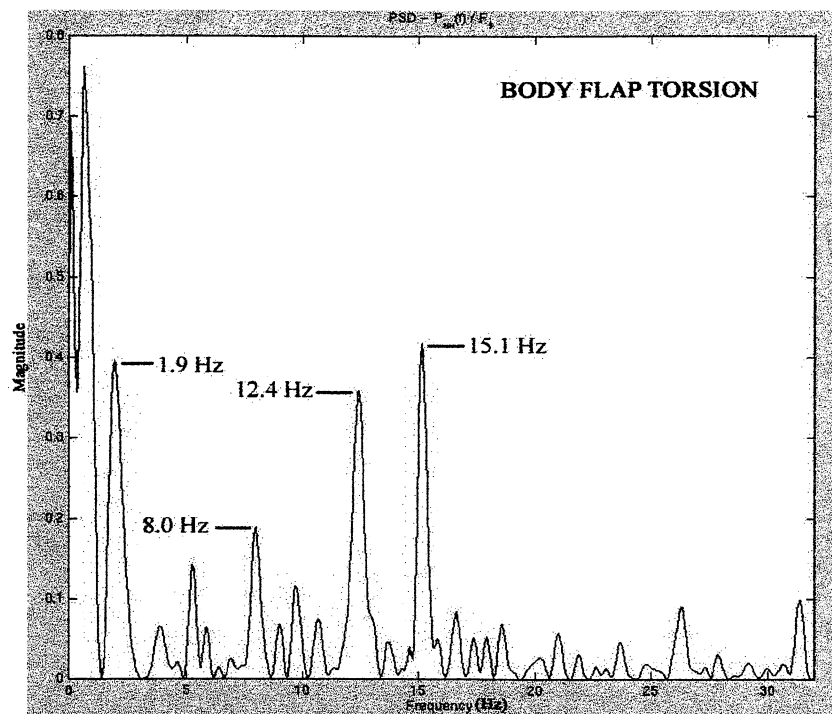
The almost seven inch amplitude of the body flap motion seen on STS-97 is higher than that seen on STS-86 and similar to that seen on STS-84. The global frequency is approximately the same for the three missions. The STS-97 torsional frequency is similar to STS-86.

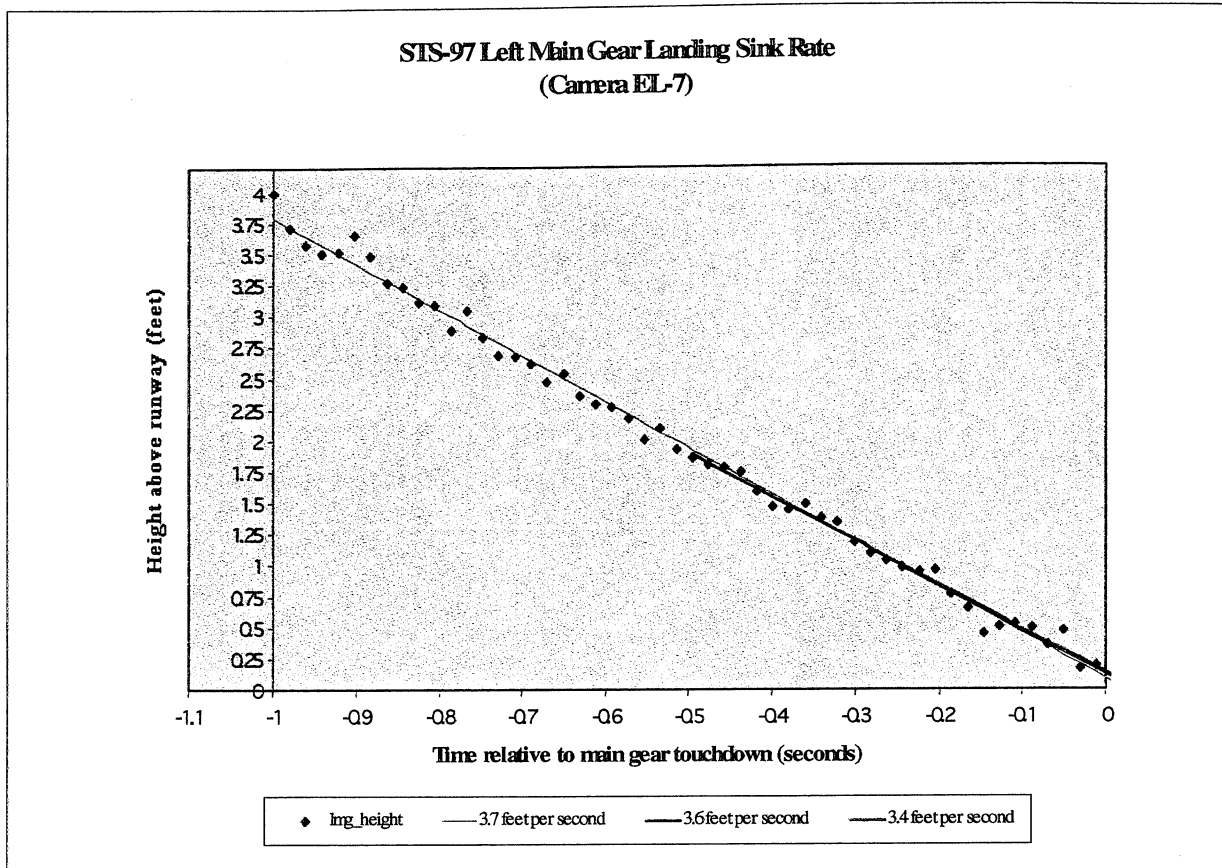
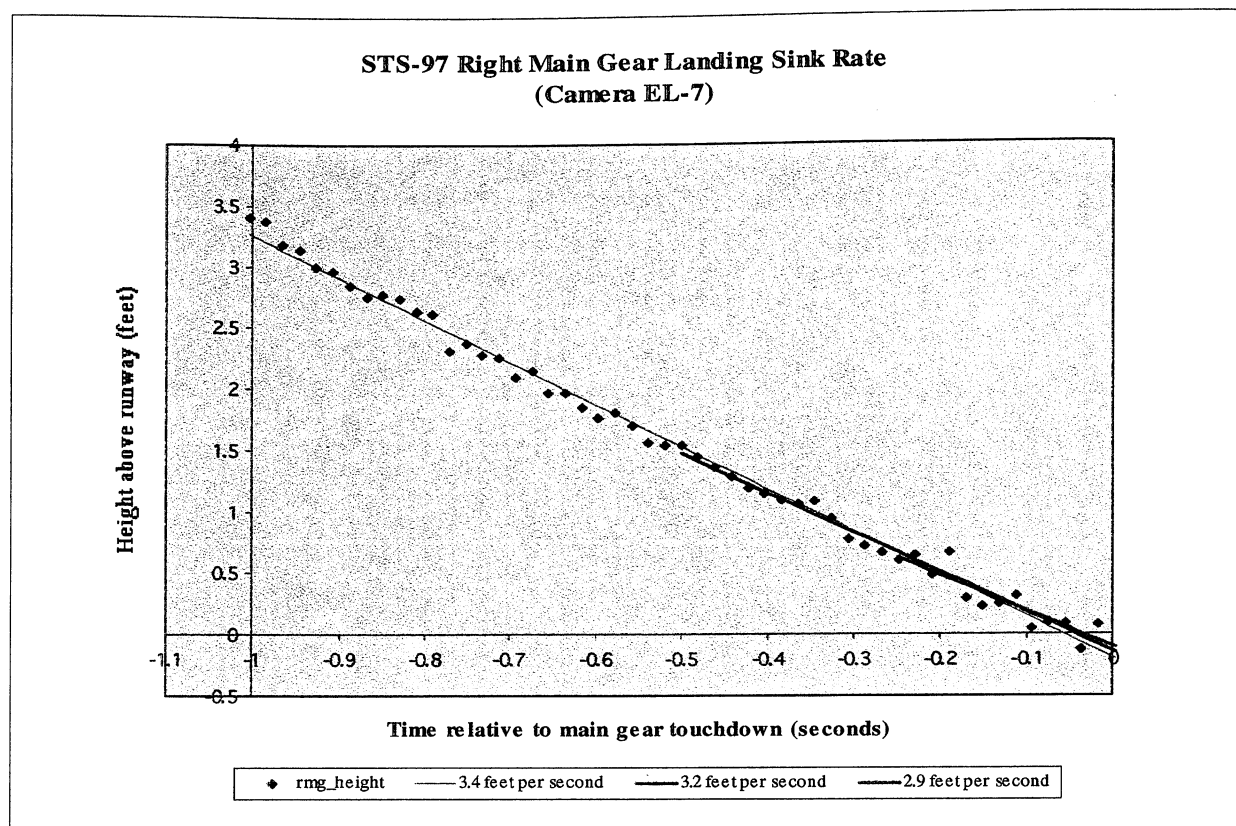
The main gear sink rate for STS-97 landing at one second, at half a second, and at a one quarter of a second are provided in Table 2.9. The left main gear sink rate is relative to left main gear touch down; the right main gear and the midpoint between the main gear are relative to right main gear touch down. Plots describing the sink rates for the individual gears are shown in Figures 2.9 (A) and 2.9 (B).

The maximum allowable main gear sink rate values are 9.6 feet / second for a 212,000 lb. vehicle and 6.0 feet/second for a 240,000 lb. vehicle. The landing weight of the STS-97 vehicle was estimated to be 198,006 lbs.

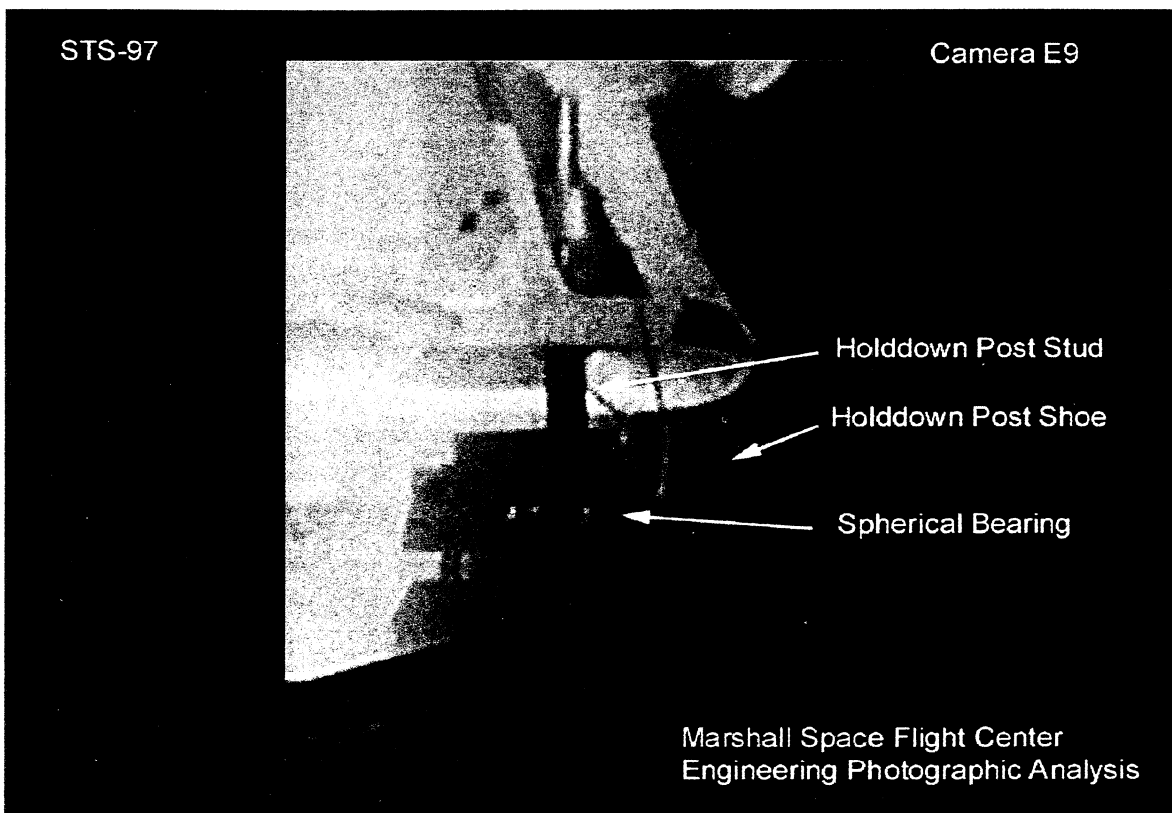
Figure 1. Stud Hang-up on HDP M1

A stud hang-up was observed, from film camera E9, on RSRB Holddown Post M1. The Holddown Post shoe was pulled up with vehicle showing the spherical bearing. The stud appeared to be fully extended until separation from SRB. A twang was observed at separation from vehicle. After separation, the shoe returns to rest position and stud falls into HDP hole. Apparent minor debris was observed emanating from SRB foot hole on stud separation.

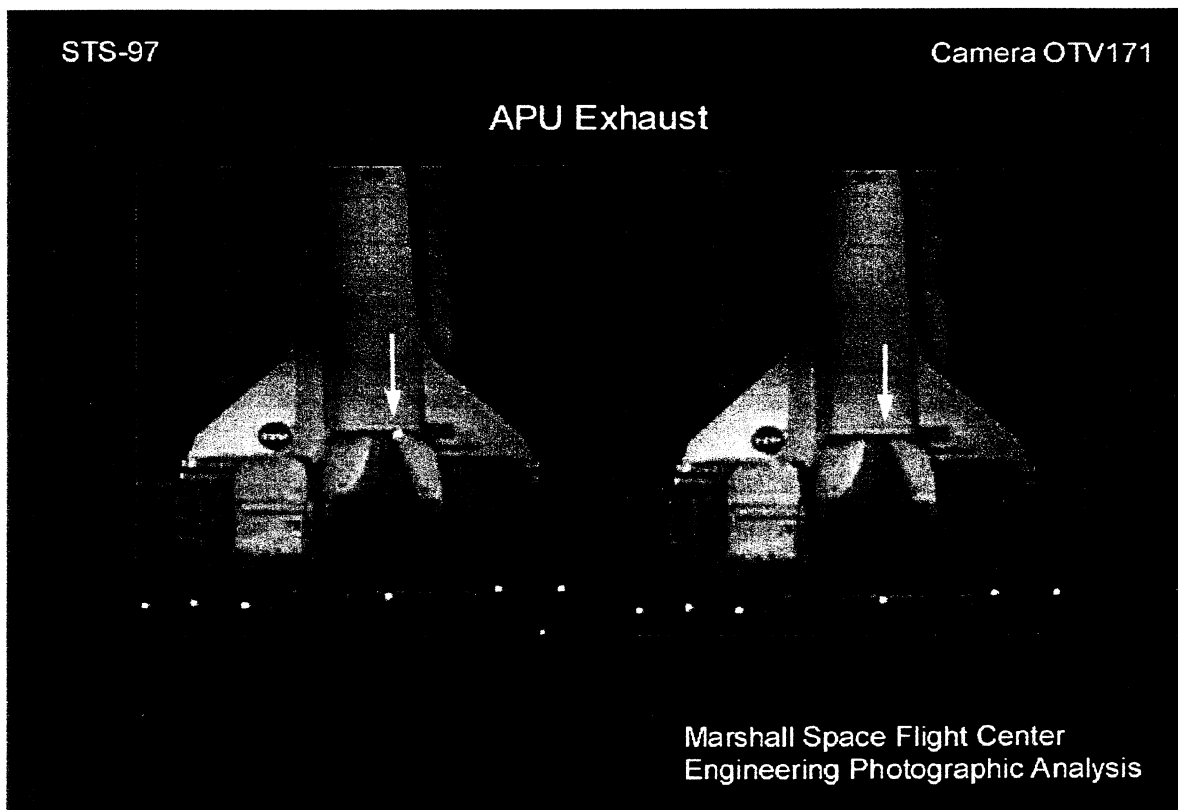
Figure 3. Top View: APU Exhaust Flame at Lift-off

Recent missions (STS-92, STS-103, STS-106, STS-99, STS-101, STS-93, and STS-96) were reviewed for similar occurrences, but none were noted. JSC Image Analysis has reported that these flames appear similar to Orbiter flames typically seen during roll-out on night landings.

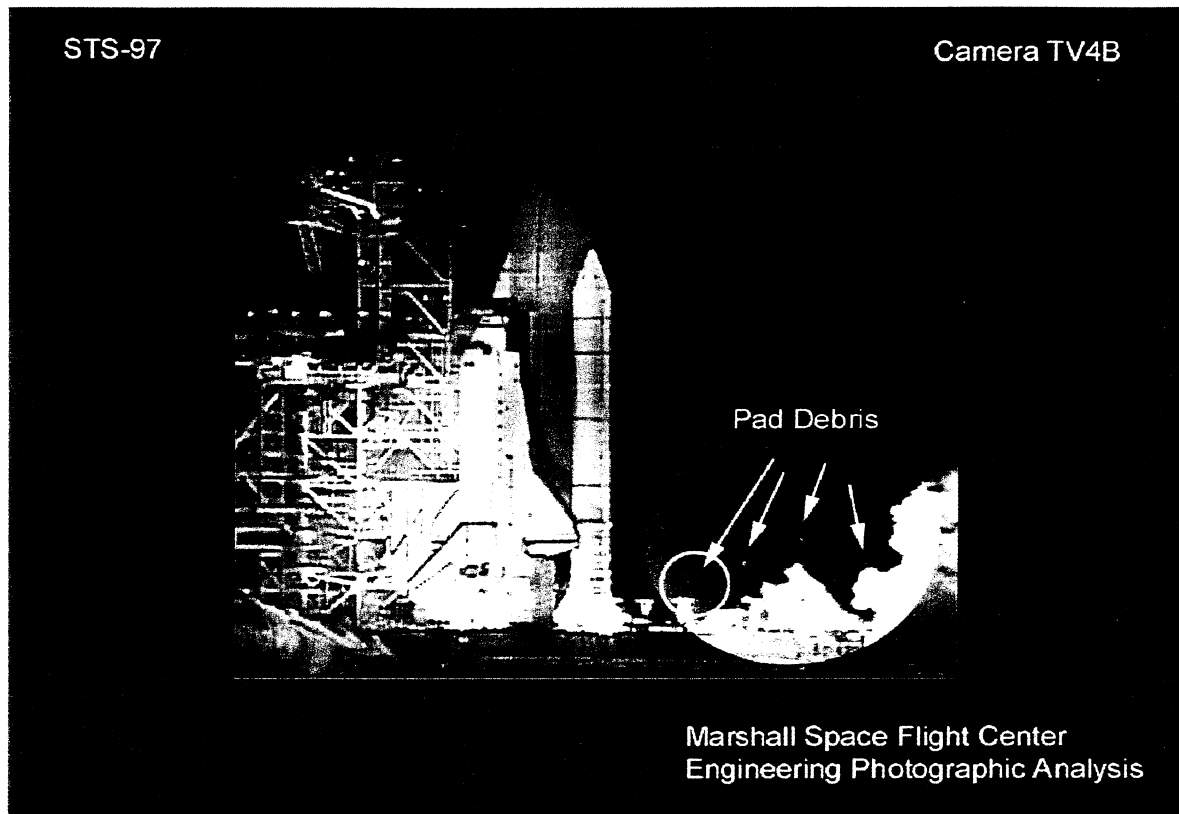
Figure 5. Pad Debris at Lift-off

The enhanced contrast area in Figure 5 illustrates typical pad debris. The debris in this image was noted to be moving away from the vehicle.
